Engineering Report 53010-1**Vibration Test**

CHC Navigation

Vibration Test

Subject two Antennas, one i80 Pole Mounted GPS Unit, one N72 Machine Mounted Receiver, and one LT500 Handheld to a Vibration Test as specified in *MIL-STD-810G*, with Change 1, dated April 15, 2014, Method 514.7, General Minimum Integrity Test and Composite Two Wheeled Trailer Vibration, as requested in CHC Navigation purchase order 15EMTCH01, dated November 3, 2015.

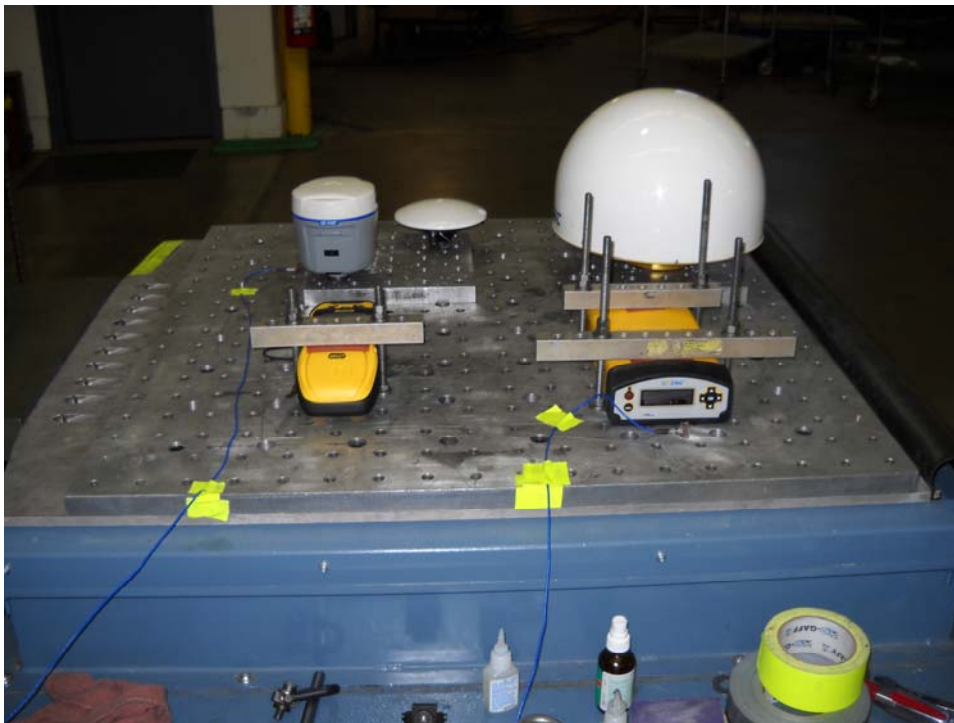
Photograph 4-8: Test units secured to the slip plate and ready for testing in the transverse axis. The control accelerometers are visible, cemented to the slip plate. Applied motion is left-to-right as this photograph is viewed.

The test units were secured to the horizontally oriented slip plate, and then rotated 90 degrees on the slip plate, and testing was conducted in the longitudinal and transverse axes, respectively, in the same manner as testing in the vertical axis.

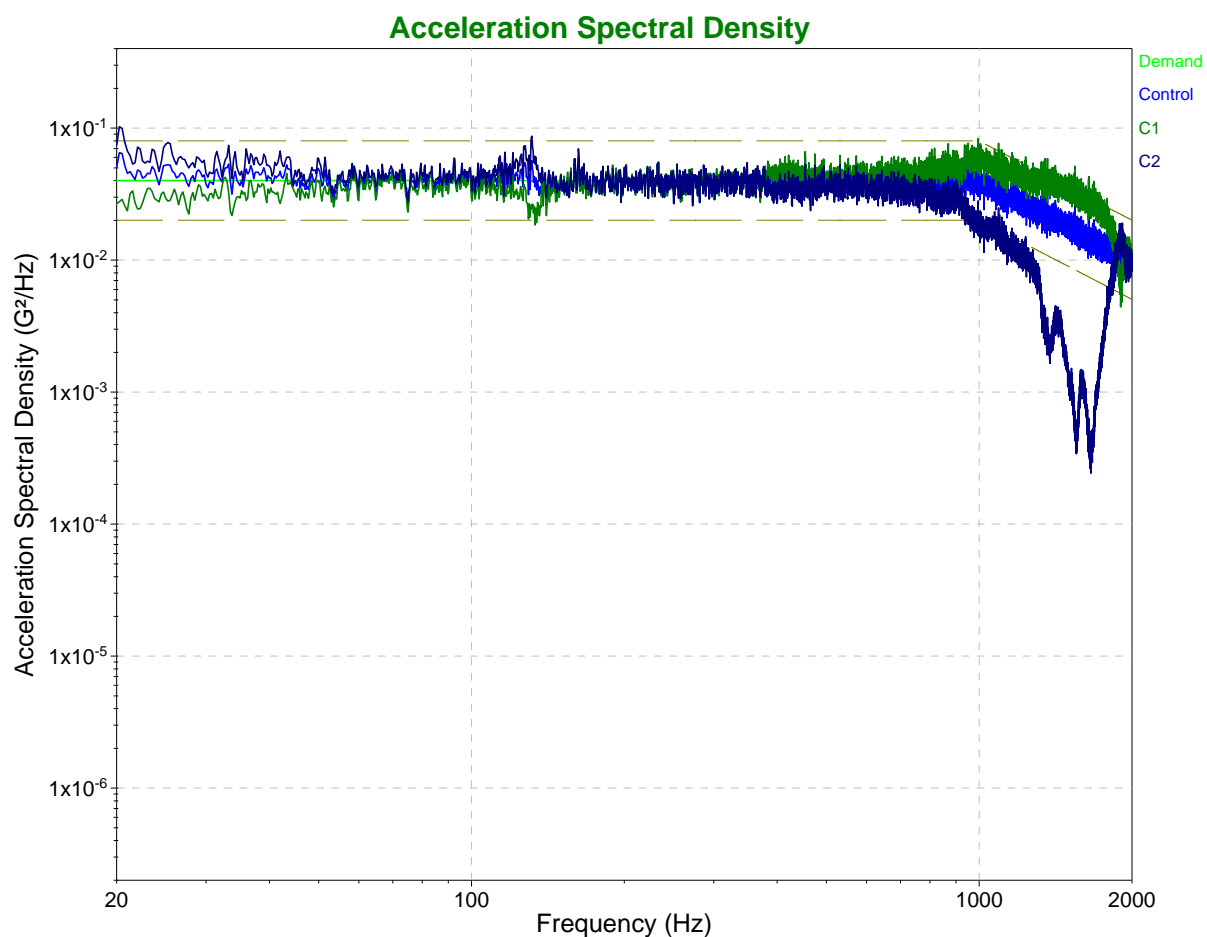
Data: C:\VibrationVIEW\Data\2015-11\2015Nov03-0605-0016.vrd
Test: C:\VibrationVIEW\Profiles\53010.vrp
Data stored on Nov 03, 2015 07:11:04
CHC Navigation MIL-STD-810G Minimum Integrity Test - Longitudinal Axis -
End of Test

Frequency	G ² /Hz	dB/Octave
20 Hz	0.04	0
1000 Hz	0.04	-6
2000 Hz	0.01005

Duration	Level
1)	1:00:00	100 %
** Test started Nov 03, 2015 06:05:34, running for 1:03:48		
** Current level: 1, running at 100 % for 1:00:00 of 1:00:00

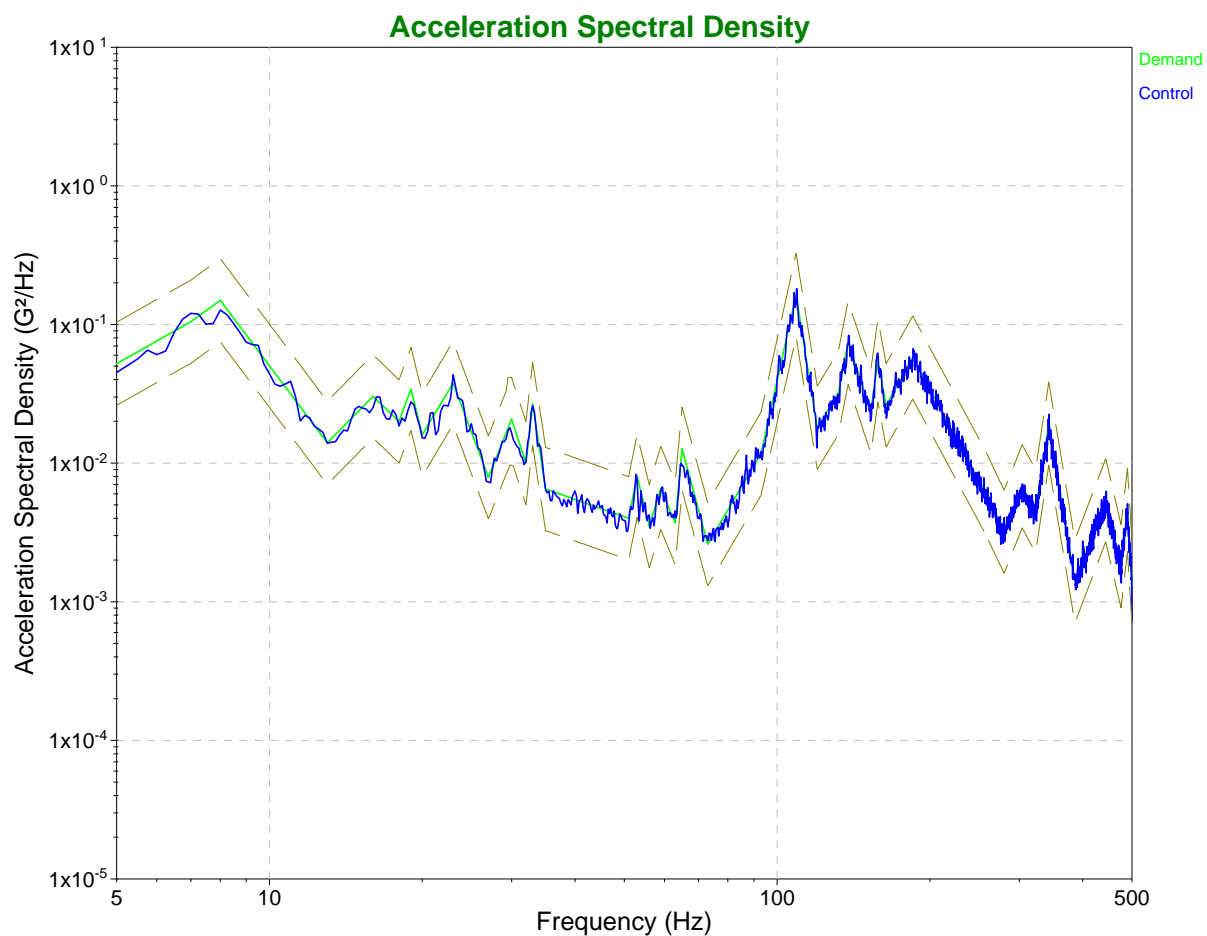
Data: C:\VibrationVIEW\Data\2015-11\2015Nov03-0839-0014.vrd
Test: C:\VibrationVIEW\Profiles\53010L.vrp
Data stored on Nov 03, 2015 09:43:23
CHC Navigation - Longitudinal Axis MIL-STD-810G Composite Two Wheeled Trailer -
End of Test

Duration	Level
1)	1:00:00	100 %
** Test started Nov 03, 2015 08:39:09, running for 1:02:17		
** Current level: 1, running at 100 % for 1:00:00 of 1:00:00
